## **Stage 1 Road Safety Audit**

**Proposed Social Housing Development at  
St Joseph's Rd, Portumna**

On behalf of **Galway County Council**

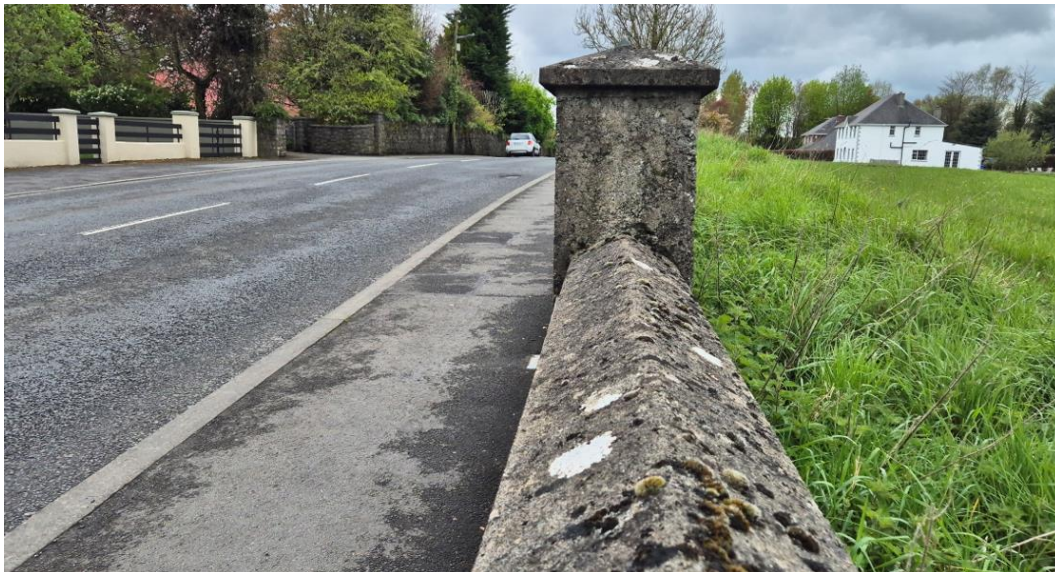
##### 3.2.1 R352 Junction Visibility

**Problem:** There is an existing masonry wall along the development side of the R352. The proposals drawings also indicate tree planting to the front of the development. There is concern that either, or both, the wall or tree planting will restrict drivers' visibility of approaching vehicular or pedestrian traffic when attempting to exit the development.

**Hazard:** Motorists may exit the development and impact with either R352 traffic or pedestrians.

**Recommendation:** The Design Team should ensure suitable clear junction visibility splays are provided and maintained.

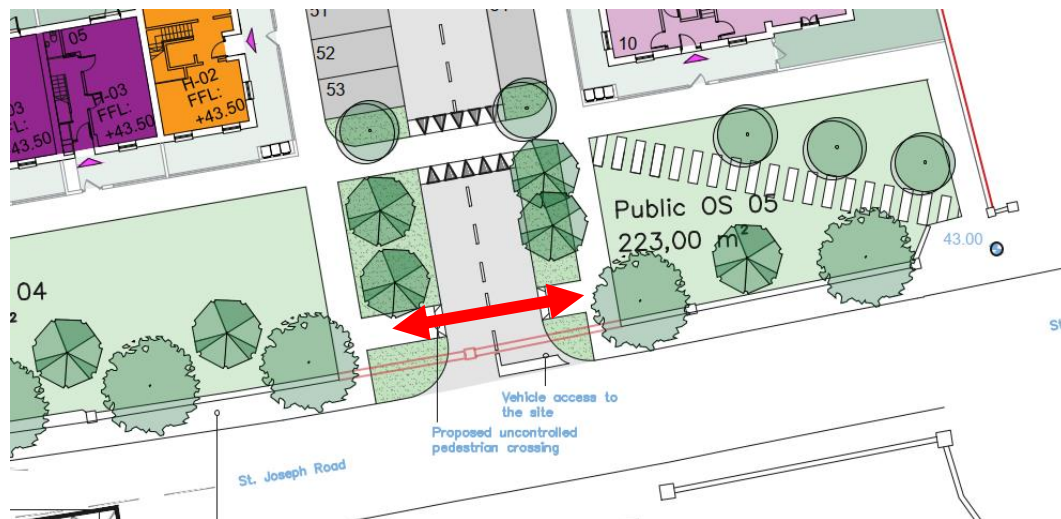
### 3.2.2 R352 Footpath

**Problem:** The footpath to the development side of the R352 is shown on the drawings to be diverted into the development. Users of this footpath are unlikely to deviate so far off of their desire line. These users are likely to cross closer to the mouth of the development junction close to the R352 carriageway edge. Additionally, visibility to the pedestrian may be compromised for motorists who are turning left into the development by the boundary wall or landscaping.

**Hazard:** The pedestrian may slip on the wet landscaped area or trip on the high kerb and fall into the path of turning traffic.

**Recommendation:** The Design Team should relocate the uncontrolled crossing closer to the desire line.

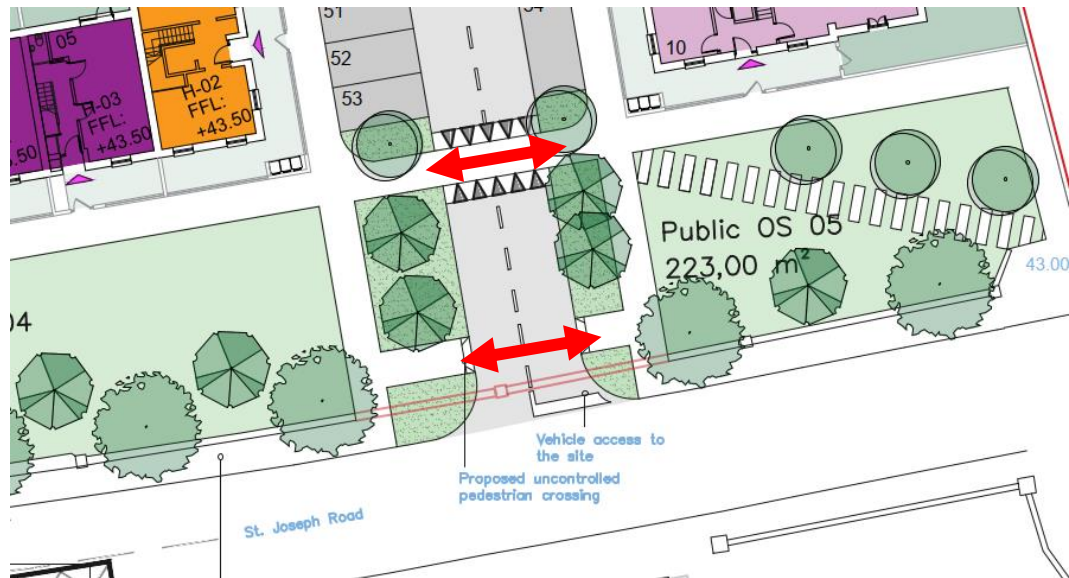
#### 3.3.1 Internal Pedestrian Crossing at Entrance to the Development

**Problem:** There is a pedestrian priority crossing of the development spine road in close proximity to the R352 junction and the uncontrolled crossing adjacent to the R352.

**Hazard:** Motorists exiting the development may concentrate on the pedestrian priority crossing and fail to observe pedestrians at the nearby uncontrolled crossing. A similar problem may exist for motorists entering the development.

**Recommendation:** The Design Team should omit the pedestrian priority crossing at this location.

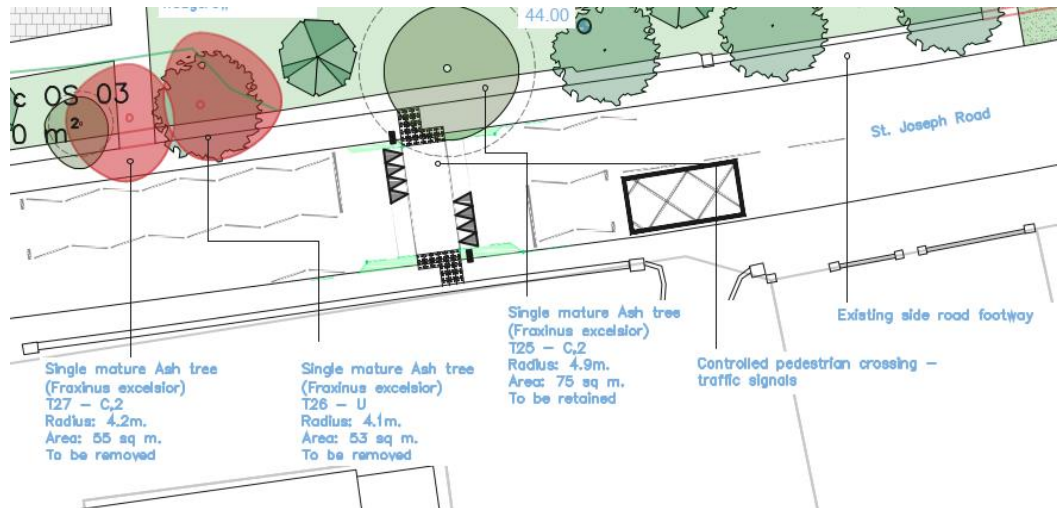
### 3.3.3 R354 Signal Controlled Crossing (2)

**Problem:** There is a proposed signal controlled pedestrian crossing located on the R354. To the east of this crossing there is a yellow box road marking, to keep the access to the dwelling house clear. The provision of the yellow box marking results in the minimum recommended number of zig-zag markings not being provided. The zig-zag markings indicate the crossing “controlled zone” where parking and/or pedestrians crossing the road should not occur. The zig-zag markings also provide warning to the motorists of the crossing ahead.

**Hazard:** Vehicle / pedestrian impacts may result.

**Recommendation:** The Design Team should omit the yellow box markings and extend the zig-zag markings.

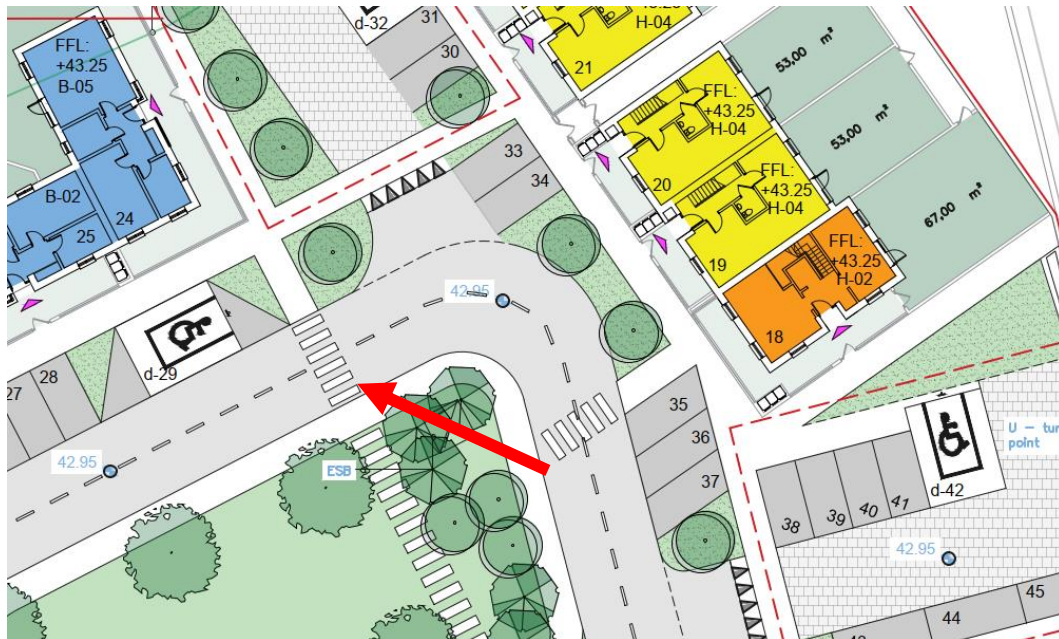
### 3.3.4 Forward Visibility Opposite Unit 19

**Problem:** There is a very tight bend on the estate road near unit 19. There is tree planting indicated on the inside of this bend, that may restrict forward visibility for the motorist.

**Hazard:** Impact with crossing pedestrians or detritus in the road may result.

**Recommendation:** The Design Team should ensure suitable clear forward visibility is provided throughout.

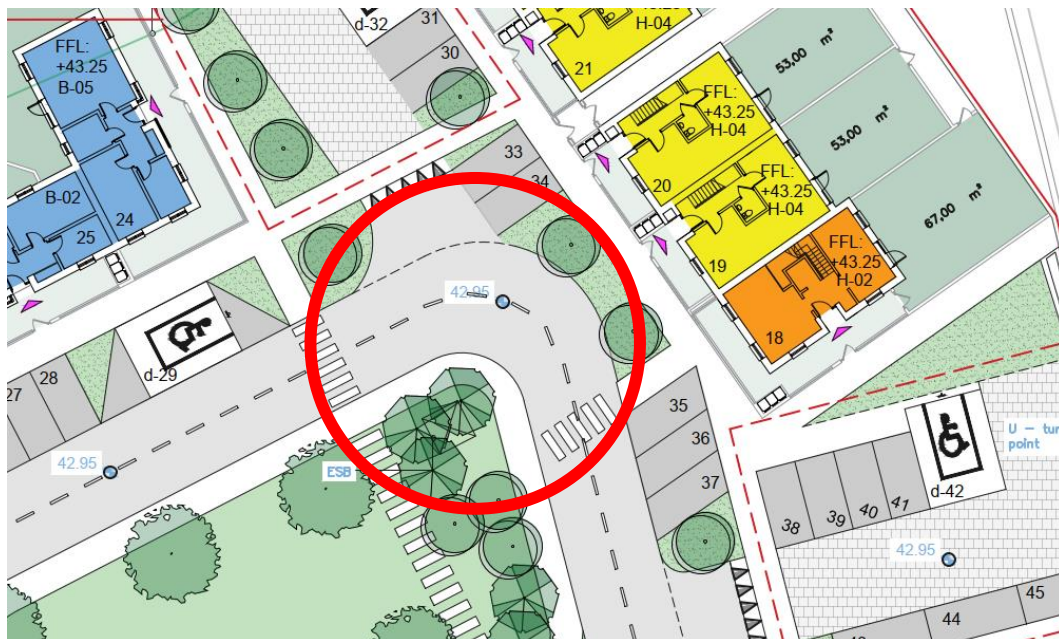
### 3.3.5 Horizontal Alignment Opposite Unit 19

**Problem:** There is a very tight bend on the estate road near unit 19. There is concern that opposing cars may not be able to pass at this location.

**Hazard:** Head-on impacts may result.

**Recommendation:** The Design Team should undertake swept path analysis and redesign the bend if necessary for two opposing cars to pass.

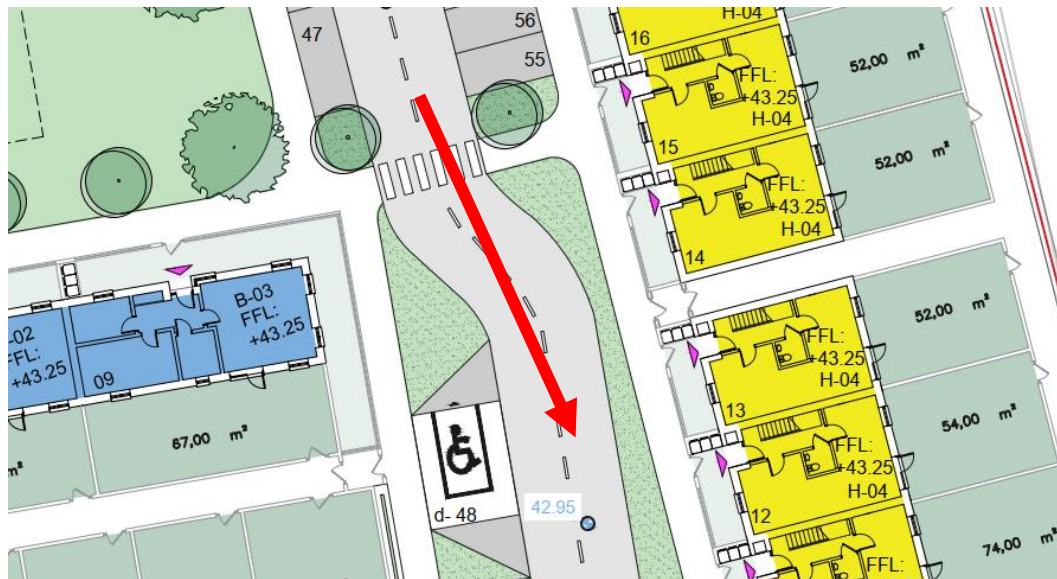
### 3.3.6 Switch-back Bend Near Unit 14

**Problem:** There is a switch-back bend in the carriageway near unit 14. There is concern motorists may become complacent and drive the “racing line” through this section of road.

**Hazard:** Impact with opposing road users, possibly cyclists may result.

**Recommendation:** The Design Team should reduce the severity of the switch-back bend or introduce a central median to prevent vehicles crossing the centre of the road.
